✓
Special Report 80-25

June 1980

**ROOFS IN COLD REGIONS: MARSON'S
STORE, CLAREMONT, NEW HAMPSHIRE**

Wayne Tobiasson and Charles Korhonen

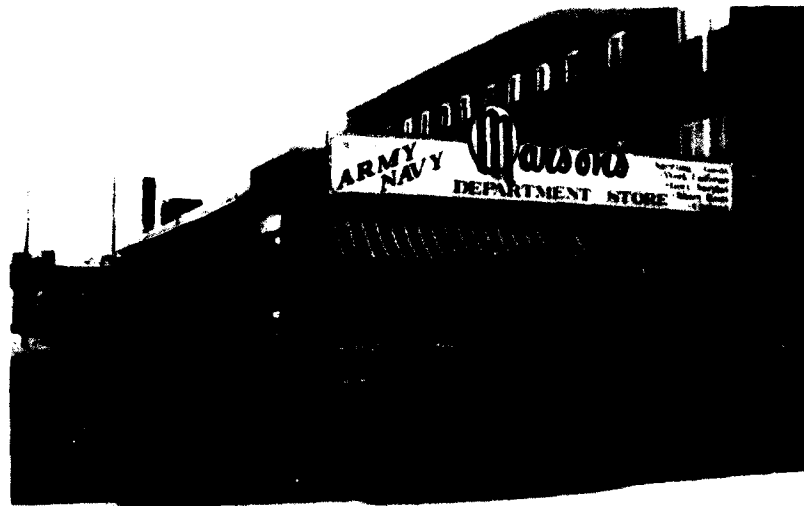
Marson's Army-Navy Department Store (Fig. 1) is located on Washington Street in Claremont. Mr. Martin Borofsky has owned and operated the store for some time. The old waterproofing consists of a conventional, hot-applied, built-up bituminous membrane. The roof deck is wood. No insulation or vapor retarder is present between the deck and the old membrane. Prior to 1975 roof leaks were a chronic problem. Mr. Borofsky made several attempts to solve them by overcoating the existing roof with cutback asphaltic coatings. He never succeeded in eliminating leaks using this approach and in 1975 decided to invest in a new membrane. A Sarnafil representative recommended that a layer of fiberboard be placed over the existing, essentially flat membrane and secured by mechanically fastening it into the wood deck below. The new PVC membrane would be fully adhered to the fiberboard with Sarnacol 2170 adhesive. The system was installed during a two to three week period in December of 1975.

Figure 1. Marson's store.

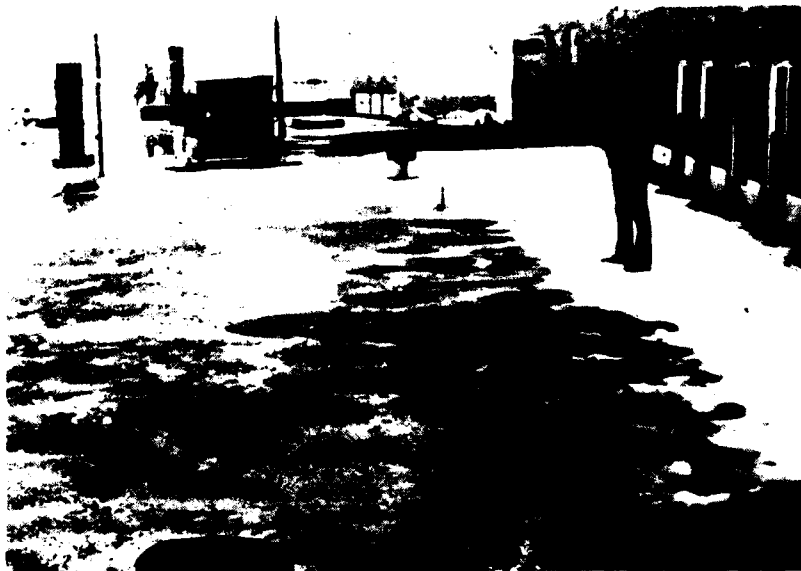
In Figure 1, it is evident that this one-story building abuts a three-story building. This is also shown in Figure 2 which was taken on the roof near the front of the store looking toward the rear. A few small vents on the roof, a chimney at the rear, and a roof-mounted air conditioner are also evident in Figure 2. The other end of the roof is shown in Figure 3.

Figure 2. Roof, looking toward rear of store.

Snow and ice were evident on portions of the roof (Fig. 2 and 3). In places the depth of ice exceeded 1 in. (2.5 cm) and perhaps approached 2 in. (5 cm). It was about 0°F (-18°C) during our inspection, but the week prior to the inspection had been somewhat warmer. As the result of the recent cooling, several contraction cracks had developed in the ice cover prior to our visit (Fig. 18). None of these cracks appeared to have progressed through the membrane.

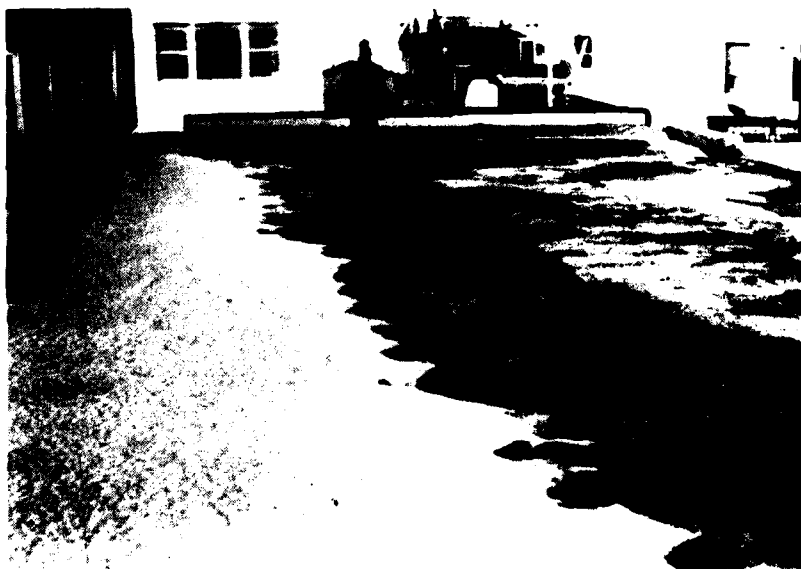
Figure 3. Roof, looking toward front of store.

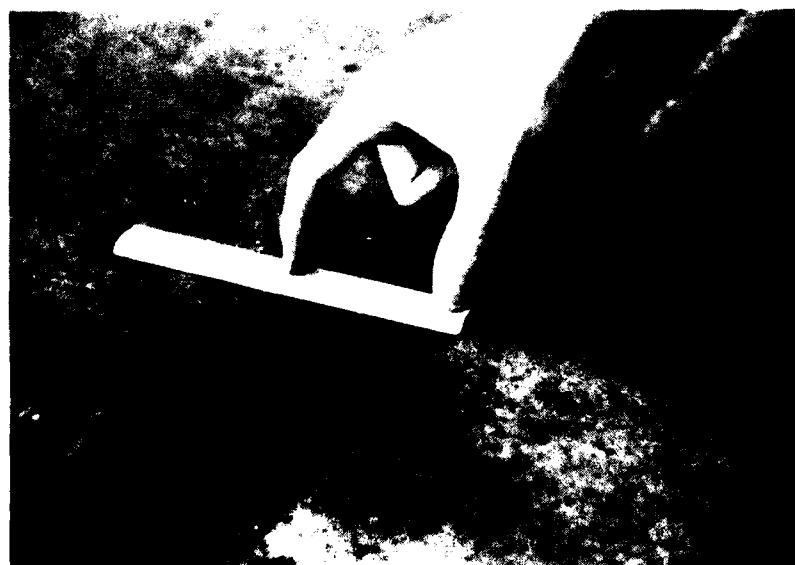
We examined the membrane in some detail, with attention to lap seams, flashings, and penetrations. Laps at seams are uniform at about 3 in. (8 cm) (Fig. 7). They are tight; no fishmouths were detected.

Figure 7. Lap seam.

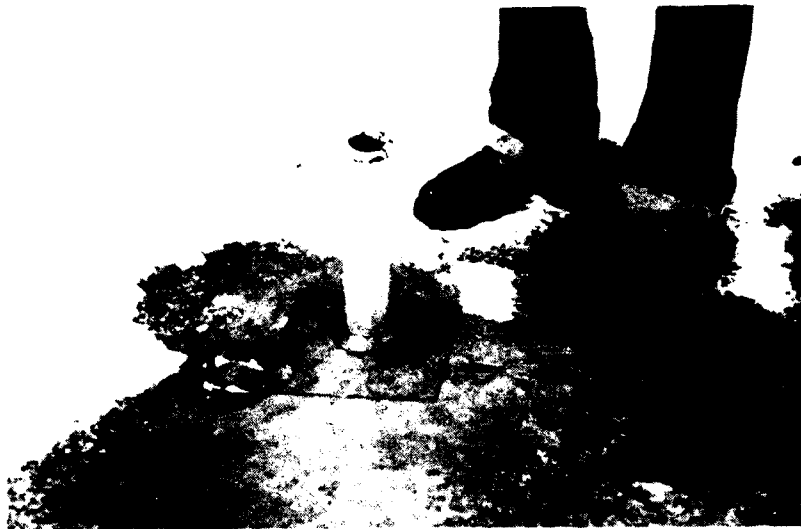
Flashings around penetrations such as plumbing vents (Fig. 8) and air exhaust-stacks (Fig. 9) were tight. Flashings at the chimney (Fig. 10), at the parapet near the front of the building (Fig. 11 and 12), and at the windows where the higher building abuts this roof (Fig. 13) were also secure.

Figure 8. Tight flashing at plumbing vent (note crushed can on membrane).

The driveway alongside this building (Fig. 1) is a convenient walkway and some people throw bottles and other objects up onto this roof. Several pieces of broken glass were observed along with cans (Fig. 8), nails (Fig. 4), old pipes and such. The bare PVC membrane appears to have survived this abuse but we recommended to Mr. Borofsky that he clear the debris from the roof and check the membrane for cuts next spring. We also suggested that a strainer be placed at the scupper and that methods such as solar-powered siphons be investigated to remove ponded water.

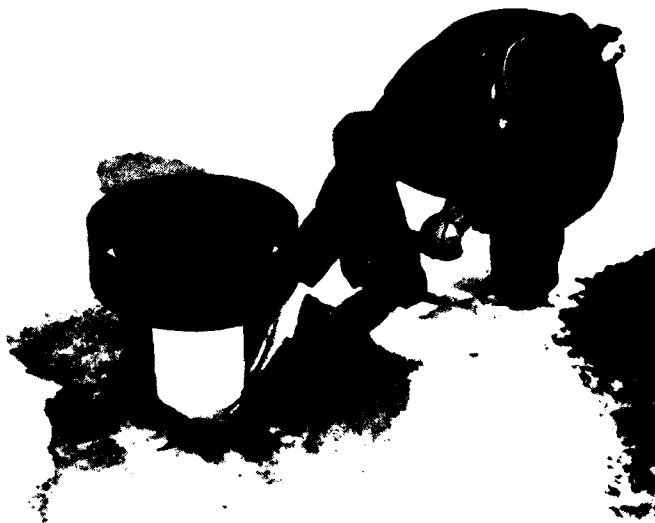
Figure 9. Tight flashing at exhaust hood.

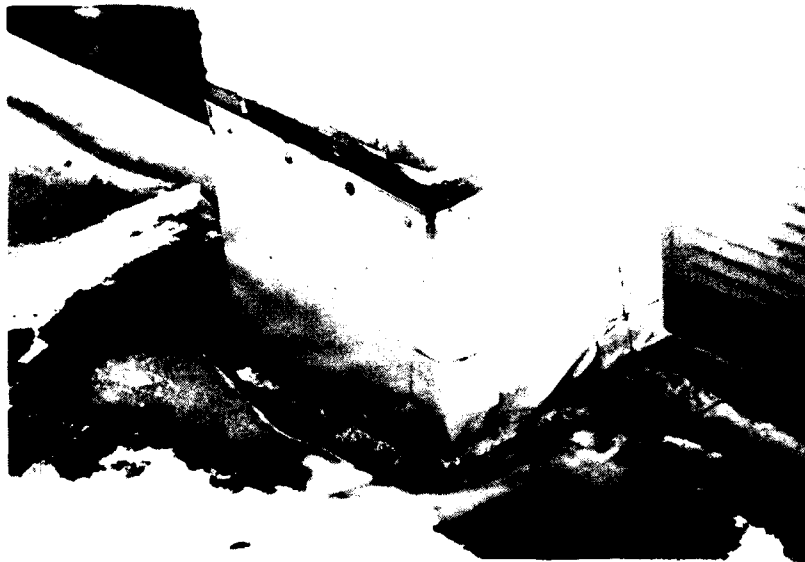
Figure 10. Chimney flashing detail.

Diagonal wrinkles were the only visual sign of concern that we detected. They are evident in Figures 10-14 and suggest that some membrane shrinkage has occurred. However, the membrane had not pulled away from the vertical walls at any of these locations; we could push back against a solid object wherever we tried.

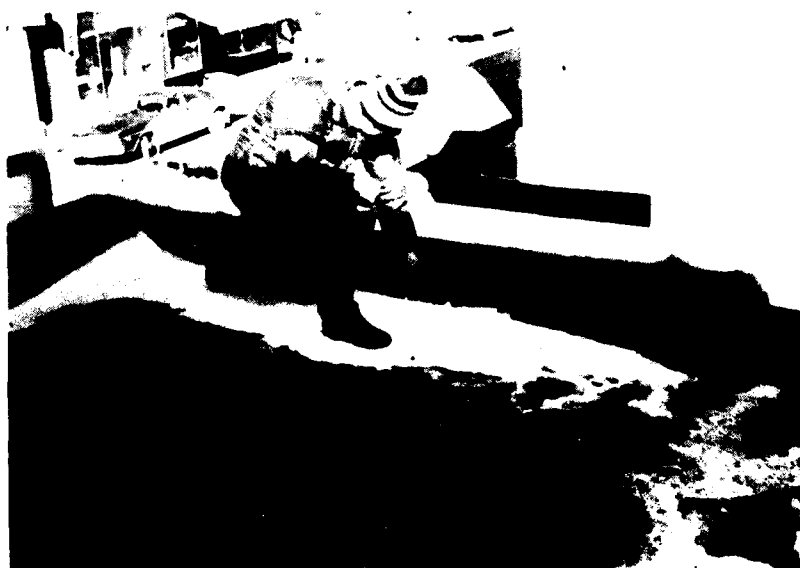
Figure 11. Parapet at front corner of building (note diagonal wrinkles).

Consequently, we feel that the wrinkles do not indicate membrane shrinkage since construction. They were probably built into the membrane during installation. No matter what their source, the only adverse effect of the wrinkles appears to be aesthetic since the membrane has not pulled flashings away from the wall or, in any way that we could see, jeopardized the waterproofing integrity of the roof.

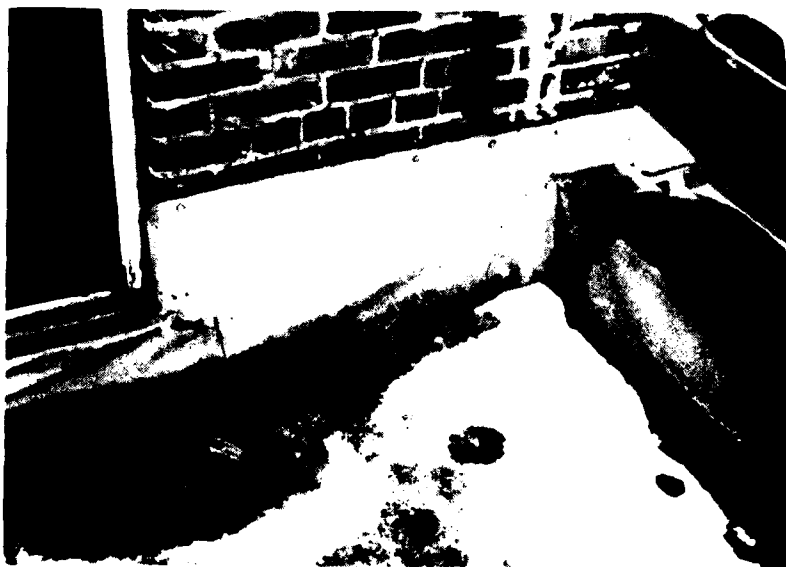
Figure 13. Flashing details at windows (note poor condition of brickwork).

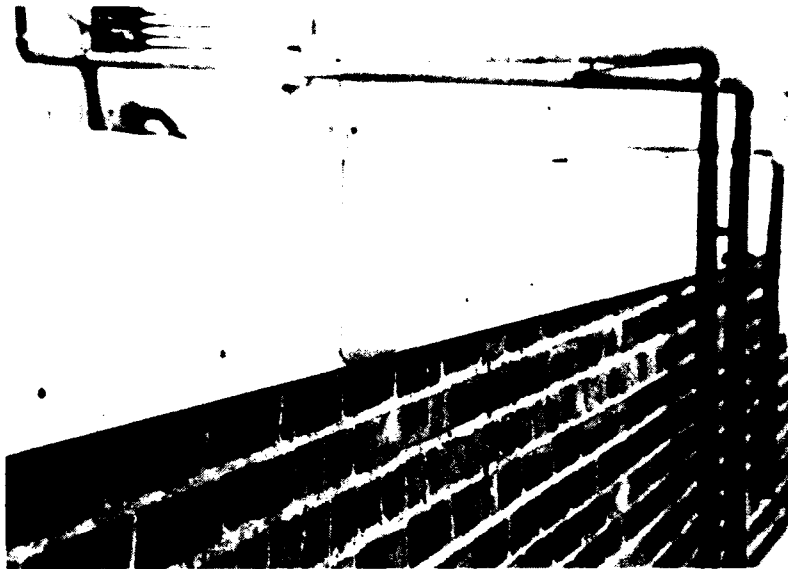
The fascia was neat and well secured. Seams in the metal were overlaid with a strip of membrane material (Fig. 15) which continued up over the edge and onto the roof membrane (Fig. 16) to strengthen the PVC there.

Figure 15. Fascia detail showing PVC cover over joint.
